4.3 ANALYSIS AND RECOMMENDATIONS - MID & WEST SIDE

4.3.1 MWR (WEST) - AREA #3W

BLDGs. 1900-1910 - OFFICER'S CLUB COMPLEX BLDG. 1911 - FLIGHT CREW QUARTERS

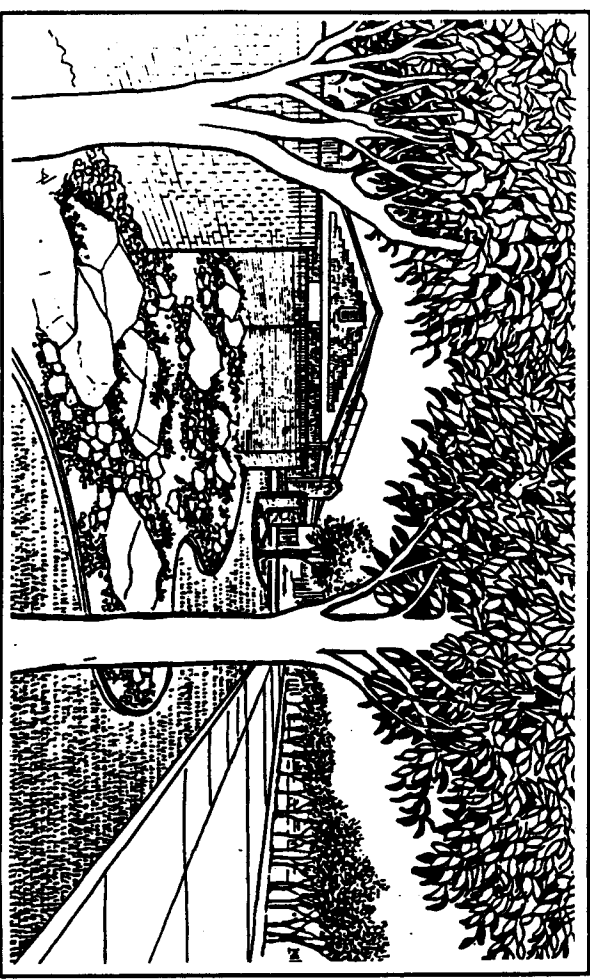
- *Bldg. 1025 is not compatible with Bldg. 1032.*
- *Chain link fence is unattractive and does not effectively screen clutter.*
- *The land between the fence and Kirtland Road lacks a landscaped buffer.*
- *Right angle parking off Kirtland Road presents a potential hazard.*
- *Site use is visually incompatible with adjacent flight line use and restricts potential expansion of flight operations.*

- *Remove chain link fence and install a solid screen wall using split rib CMU screen wall, color to match Bldg. 1032.*
- *Re clad the north side of Bldg. 1025 with a split-rib CMU. Paint the other three sides brown and paint the blue accent bands to match Bldg. 1032.*
- *Landscape between fence and Kirtland Road with a curvilinear design to introduce rhythm.*
- *Relocate this area to allow for future expansion of flight operations.*
- *Eliminate 90 degree parking from Kirtland Road and construct a parking lot.*

Sketch of suggested improvements to this area

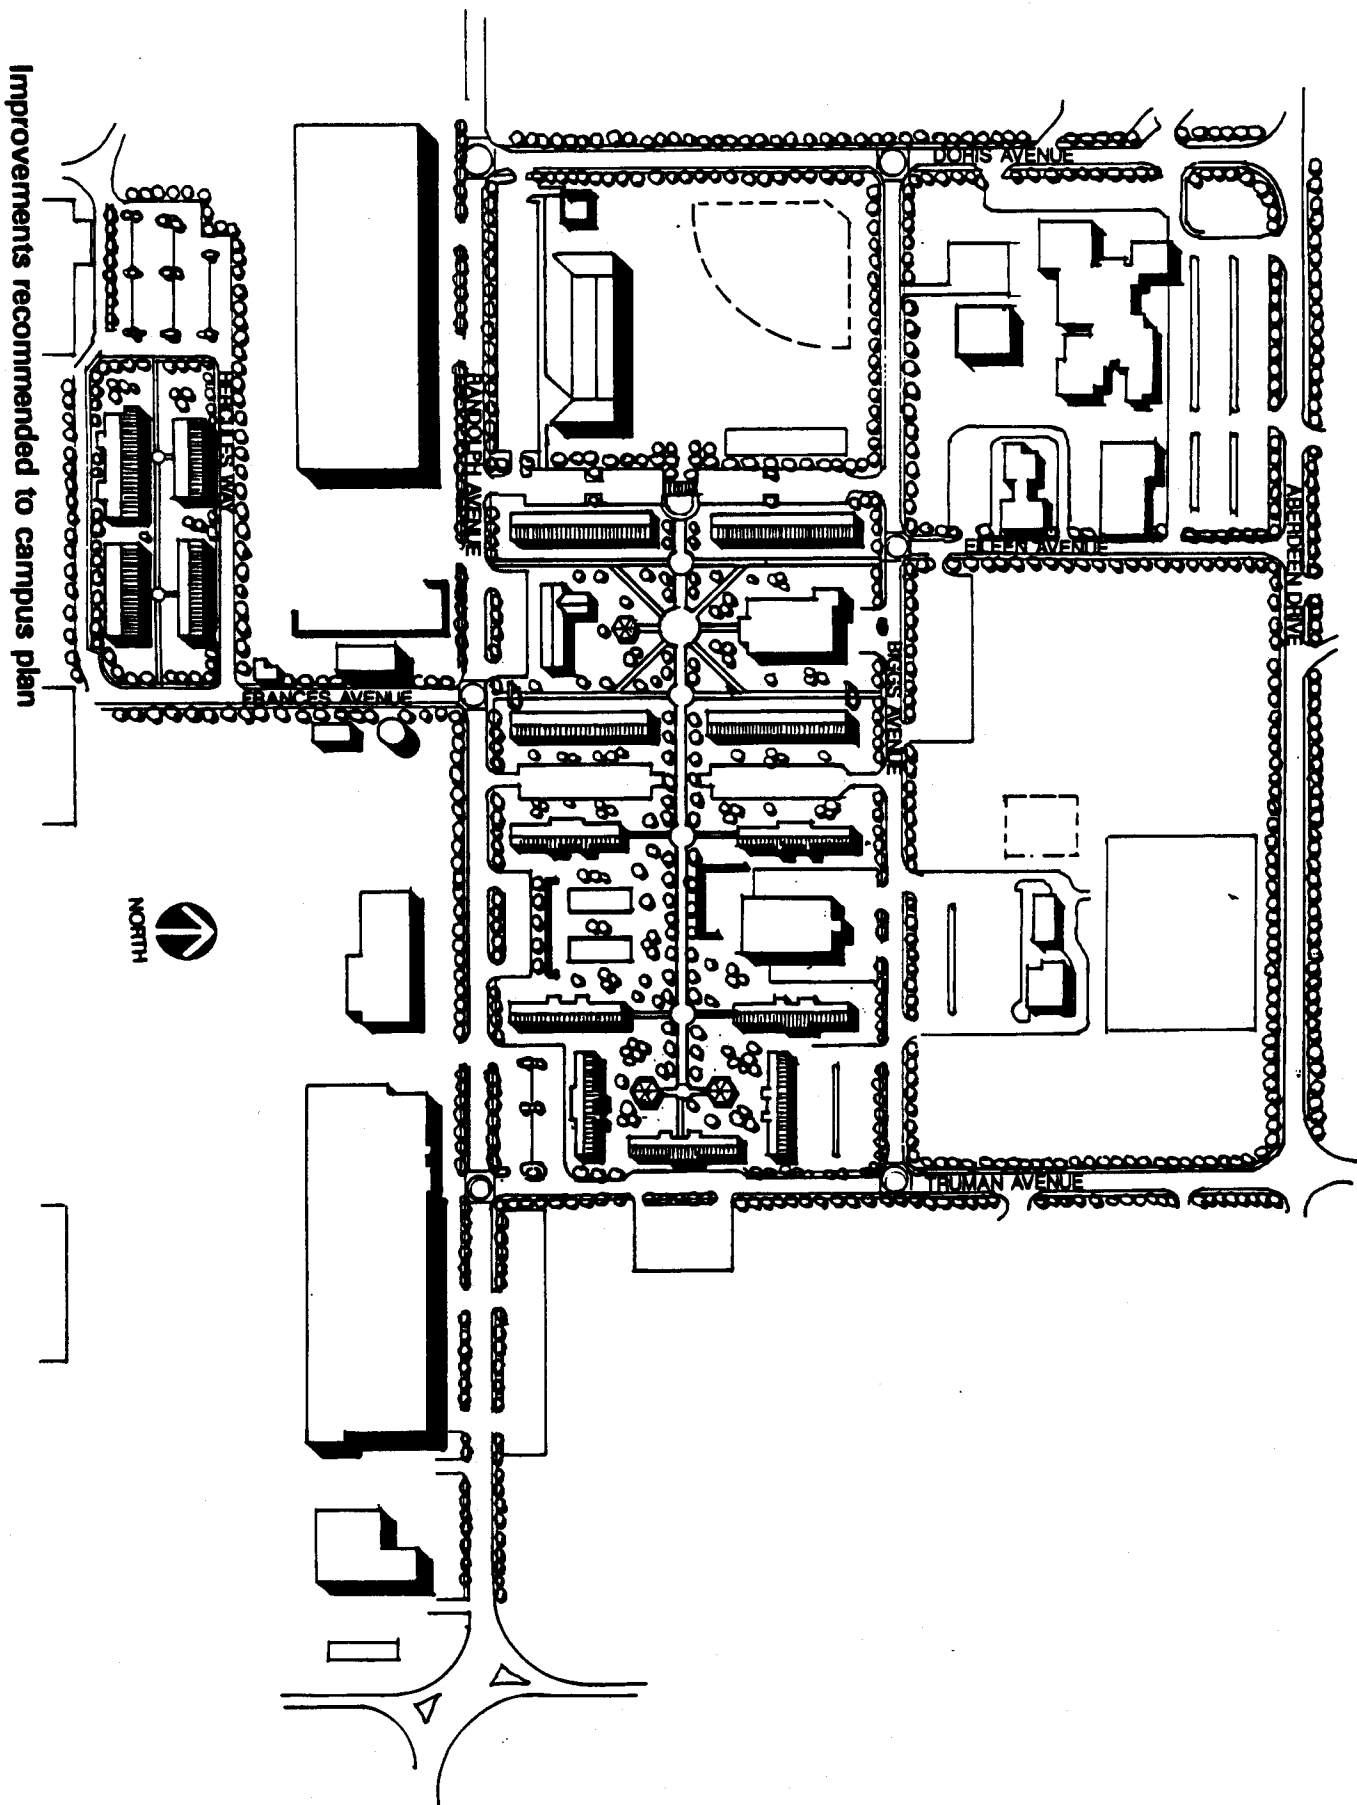
- *Boundaries of campus are weakly defined; it lacks a central focal point or plaza, as well.*
- *The campus lacks organized pedestrian circulation.*
- *Landscaping, lighting fixtures, pavilions, furniture, and signage in unified themes are lacking.*
- *Buildings lack unity in architectural themes including form, details, materials and colors.*
- *Pedestrian crossings are lacking at streets and parking lots.*

- *Define boundary edges with low landscaped walls at corners of campus.*
- *Construct portal pedestrian entrance between Bldg. 916 and 917 as shown in sketch.*
- *Provide common species ornamental trees at walkways and shade trees along street lines.*
- *Provide appropriately scaled lighting fixtures along walkways, streets, parking lots, and plazas.*
- *Develop common architectural themes as defined for each building arrangement in this section.*

Improvements recommended to campus plan

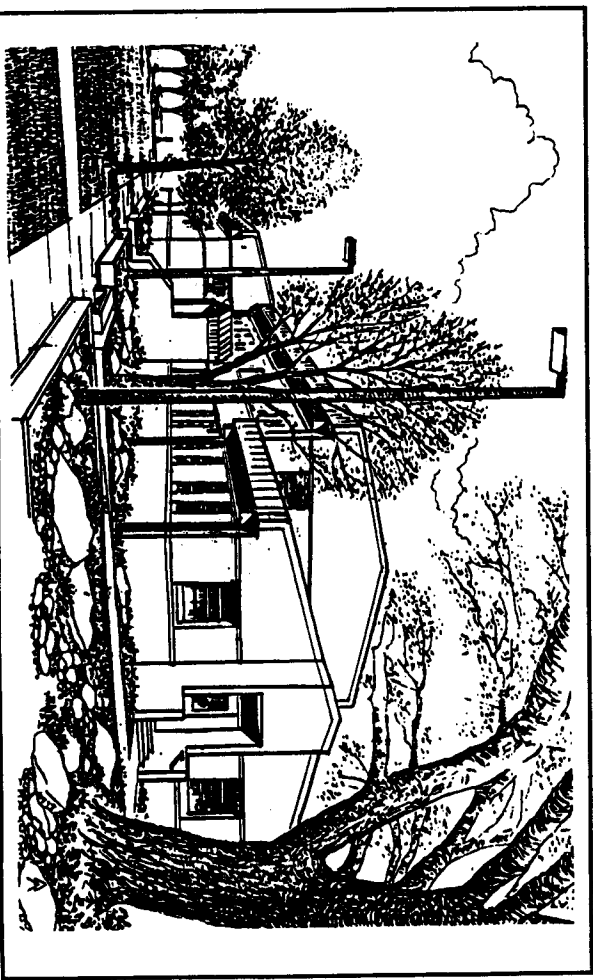
- *Buildings are remotely located and lack architectural identity to the central campus complex.*
- *Buildings have flat roofs with unattractive rooftop mechanical equipment.*
- *Grade-mounted equipment along Hercules Way creates visual clutter.*
- *Signage is not unified and not in compliance with Air Force standards.*

- *Remodel buildings to unify with architectural campus theme as shown in sketch.*
- *Locate mechanical equipment on grade and screen with stucco screen walls to conceal from view.*
- *Remove signage and replace with one entrance sign and individual signs per building.*

Perspective sketch of improvements to Bldg. 1019

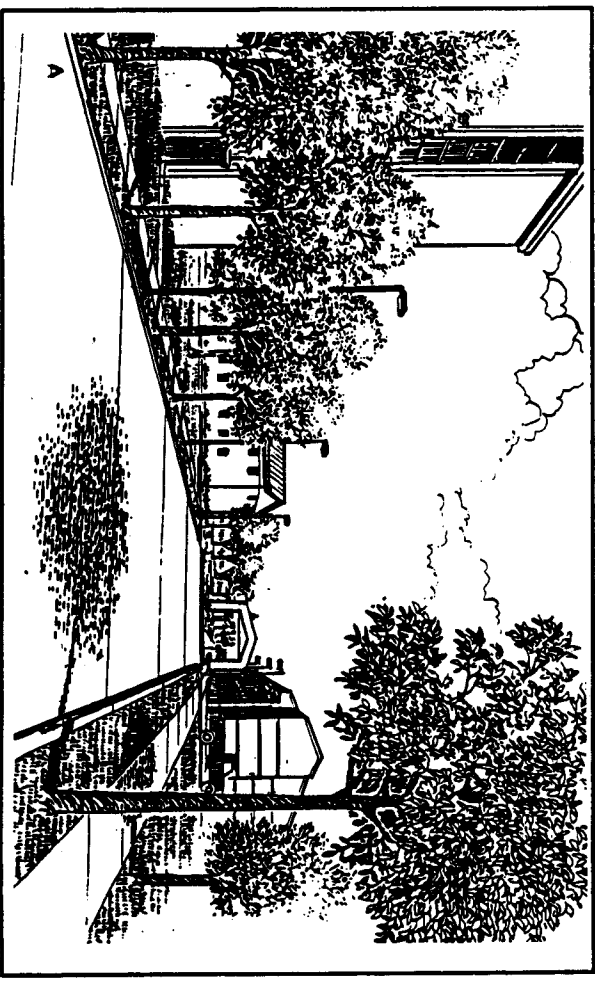
- *Sidewalks are lacking to join campus areas for pedestrian movement.*
- *Elements of unity such as landscaping and street and pedestrian lighting are lacking.*
- *Several small buildings and water storage tank on east side of the road are unattractive.*
- *Parking on the east side of the street interferes with pedestrian walks.*

- *Improve street and walkways with unified design to match the campus; i.e., landscaping, paving, lighting and signage.*
- *Remove parking on east side and install walkway.*

Sketch of street line improvements to unify campus

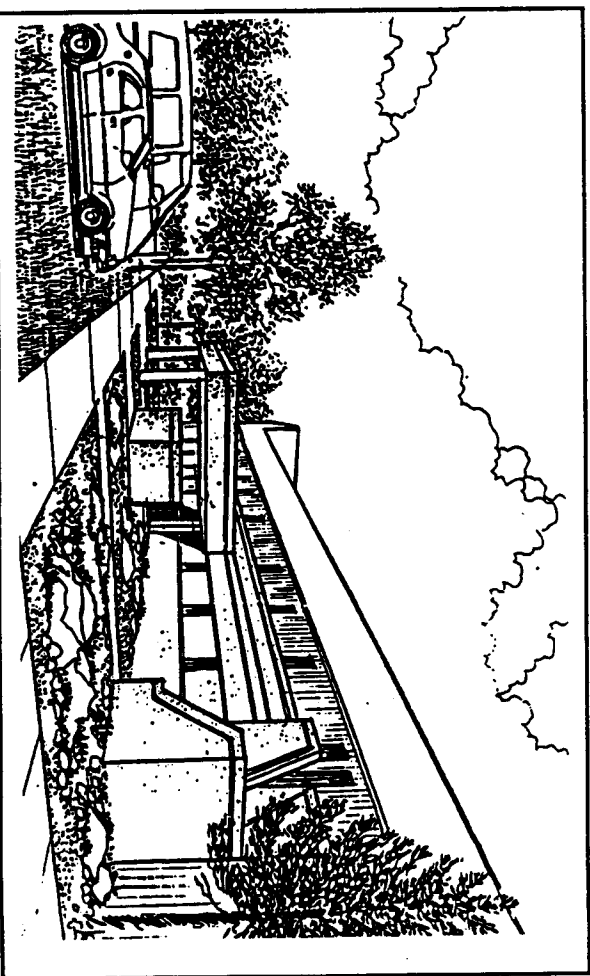
- *View of terminal and main pedestrian door is obscured from view by a small building (#334), breaching stack and parked cars.*
- *Pedestrian entrance lacks definition and competes with door to snack bar.*
- *Grade mounted electrical transformer lacks screening.*
- *Area between building and parking is stark and unattractive.*
- *Open metal stair presents an industrial image.*
- *Size of vestibule is inadequate.*

Sketch of recommended improvements to Bldg. 333
